SERVICE ANNOUNCEMENT

DATE: March 2, 2011

SUBJECT: Datacard Desktop Printer Go Green Firmware Update

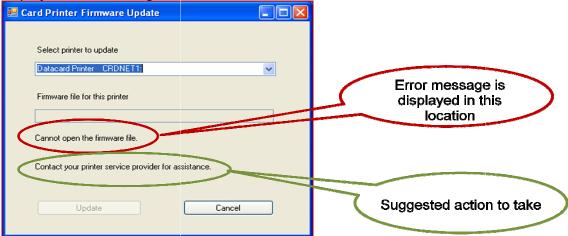
Error Message	Potential Cause	Remedial Steps	
1	Cannot open the firmware file	There is a problem with the update utility.	Download a new version of the update utility. If the update utility was obtained from a CD, reload the utility on the PC. If the problem still exists in either situation, escalate using the process outlined in the next section	
2	Cannot send the firmware file	There is a problem with the update utility.	Download a new version of the update utility. If the update utility was obtained from a CD, reload the utility on the PC. If the problem still exists in either situation, escalate using the process outlined in the next section	
3	The printer did not send the update status within the time allowed	A communications time-out with the printer has occurred.	Check the connections between the PC and printer and try to update the firmware again. If the second attempt fails, escalate using the process outlined in the next section

4	The printer is not responding	There is a problem with communications that is likely to be driver related.	Uninstall and reinstall the driver. Then perform the firmware update. See instructions below. If the second attempt fails, escalate using the process outlined in the next section. To uninstall the driver: The printer is deleted from the Printers folder in the control panel. Go to Start > Programs > Datacard Card Printers > Uninstall Driver	
			Software. Once the uninstall is complete a message pops up informing the user that the uninstall is complete.	
			Perform firmware update: The user should start the driver using the installation instructions. This can be done from the original CD or by downloading the latest driver from datacard.com (or their reseller's website if available). Installation of the driver requires they start the program, accept the EULA and plug the printer in when the program gives these instructions.

Example of displayed error messages:

If the utility fails to launch/open, please power cycle the PC and re-execute the utility. If the utility fails to launch a second time, please download (or reload) a new version of the update utility and perform the update.

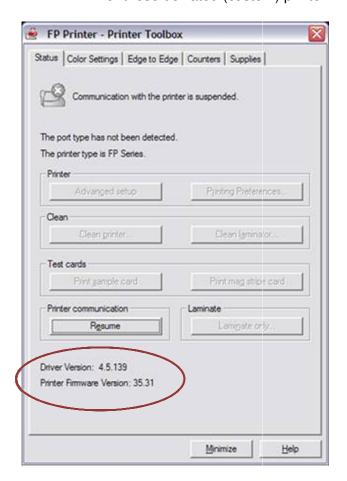
The driver will display the current version of the firmware installed on the printer as shown below. The printer is running a deviated (or custom) version of firmware if the "Printer Firmware Version" matches one of the versions shown in the table below. Update utilities will be available

for these deviated (custom) printer firmware versions by the end of May 2011.
